ASPEN BUILDERS INC. ACTIVITY CENTER –  
GYM FLOOR REPLACEMENT PROJECT  
(490 W D ST TEHACHAPI, CA 93561)

Re: **Addendum to May 22, 2020 "Flooring Failure Investigation Report"**  
File Name: Tehachapi Valley Recreation & Park District (RPD)  
J.S. Held #: 19060309

Re: **Flooring Failure Investigation Report**  
File Name: Tehachapi Valley Recreation & Park District (RPD)  
J.S. Held #: 19060309

At your request, J.S. Held conducted an investigation into the cause of failure of the gymnasium floor installed in the Aspen Builders Inc. Activity Center (ABIAC) located in Tehachapi, California.

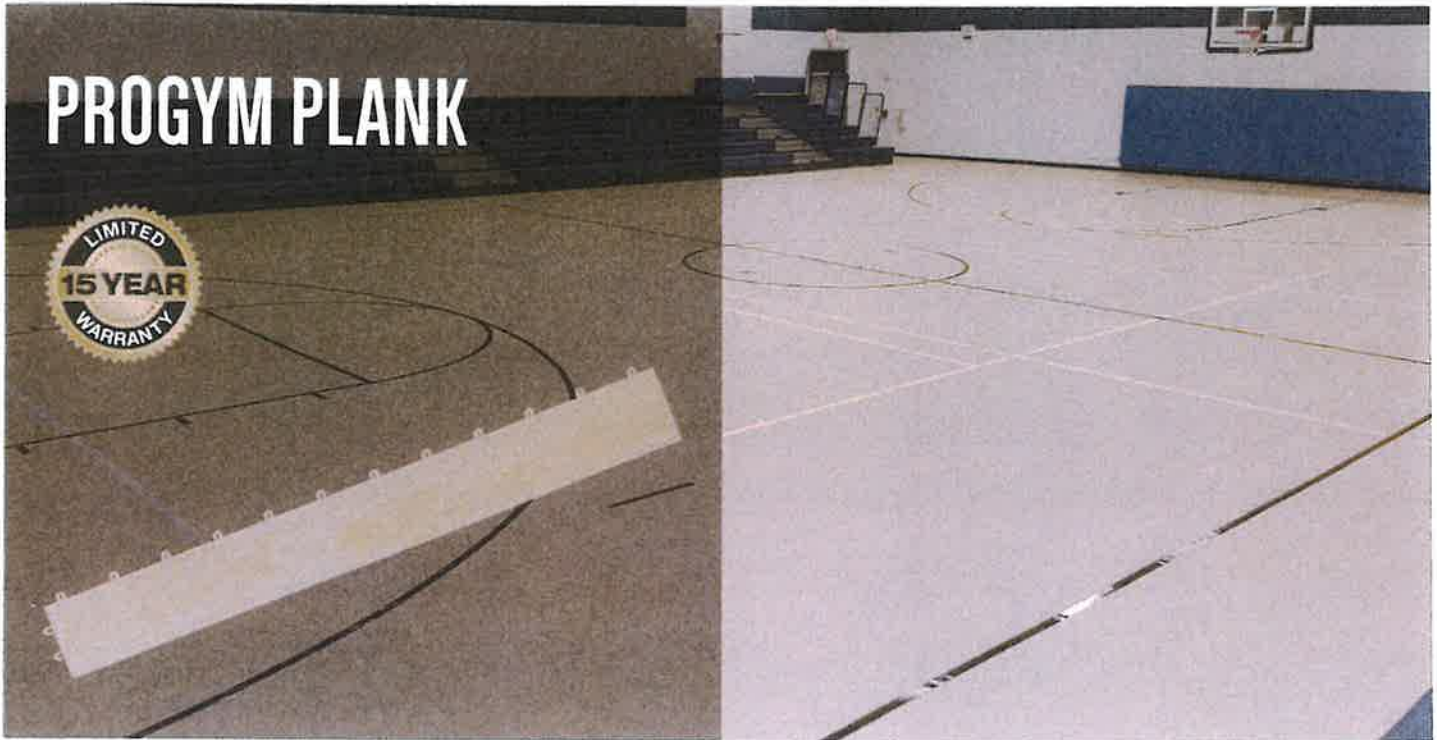
# PROGYM PLANK

ProGym Plank by Matéflex takes modular athletic flooring to the next level in beauty and functionality. ProGym Plank is the first solid-top tile that marries quality floor finishes with the versatility and durability of a raised modular floor in a plank form.

- Size: 4.15" x 36.15" x 1/2"
- Weight: 1.6 lbs./sq. ft.
- Material: Luxury Vinyl Tile in a high impact Polypropylene Base
- Extra Heavy Duty Wear Layer
- Support: Surface Supported by 196 Truncated Conical Legs & Gusseted Posts
- Locks: 28 Latch Locks
- Packing: 24 tiles per carton

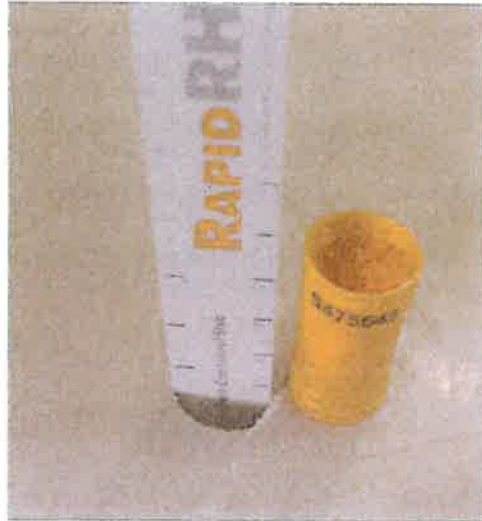
Figure 1. Rapid RH® sensor before insertion into hole drilled in the concrete to measure humidity and temperature in the interior of the concrete slab.

J.S. Held visited the ABIAC in Tehachapi California on September 4, 2019 to conduct an inspection of the sports floor, take humidity measurements of the underlying concrete, and take samples of the installed SignaFlor sports floor. Holes (3/4" diameter) were drilled in the concrete floor at three different locations and Rapid RH<sup>®</sup> sensors were installed to measure the humidity and temperature of the interior of the concrete floor per the ASTM F2170 standard as seen in Figure 1. Two-inch diameter full thickness cores, (i.e., down to the surface of the concrete) were cut in the SignaFlor at four locations where blisters were present. An example of the cut SignaFlor is shown in Figure 2 at blister location core #2 with a pre-existing fissure. The adhesion of the cores to the underlying concrete substrate was qualitatively examined during removal of the cores. The cavity and the cores themselves were examined for evidence of moisture at

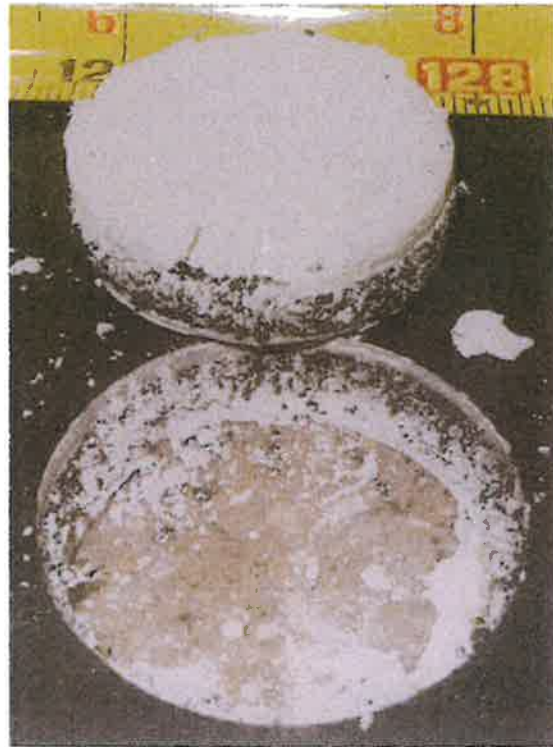
Figure 3. SignaFlor core #1 showing inverted core and cavity after removal.

Of the four SignaFlor core samples removed, SignaFlor core #1 and core #2 were firmly attached to the concrete. Removal of these two core samples was difficult and was aided with the use of a chisel. Figure 3 and Figure 4 show SignaFlor core #1 after the removal of the core and with the moisture mitigation membrane still attached to the concrete. Similarly, Figure 5 shows the epoxy membrane from SignaFlor core #2 firmly attached to the concrete slab and cohesive failure within the SignaFlor layers occurred during forceful removal.

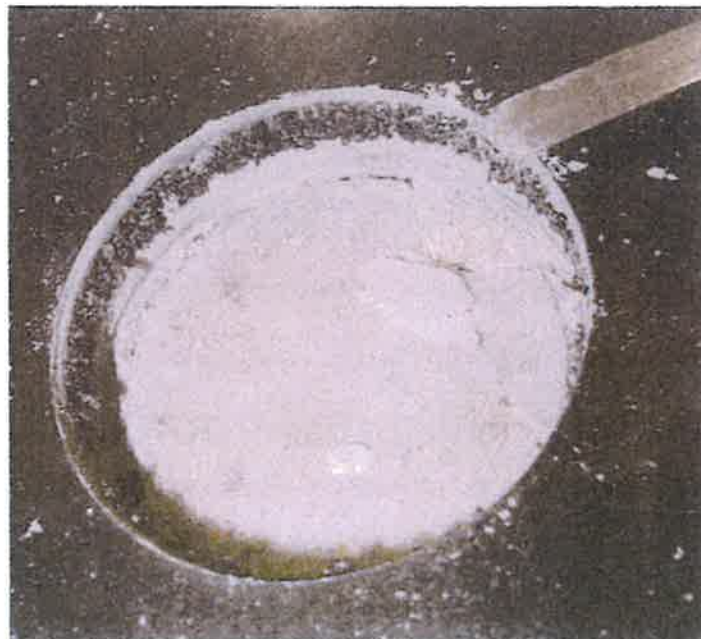
Figure 4. SignaFlor core #1 cavity. Part of the moisture mitigation membrane firmly attached to concrete.

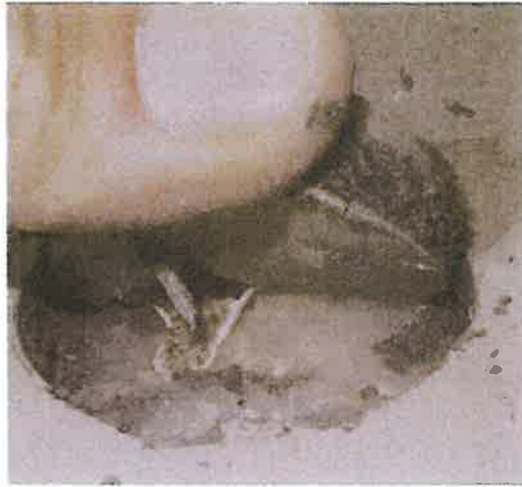
Figure 5. SignaFlor core #2 being removed. The moisture mitigation membrane was firmly attached to the concrete slab. Cohesive failure can be seen within the SignaFlor layers.

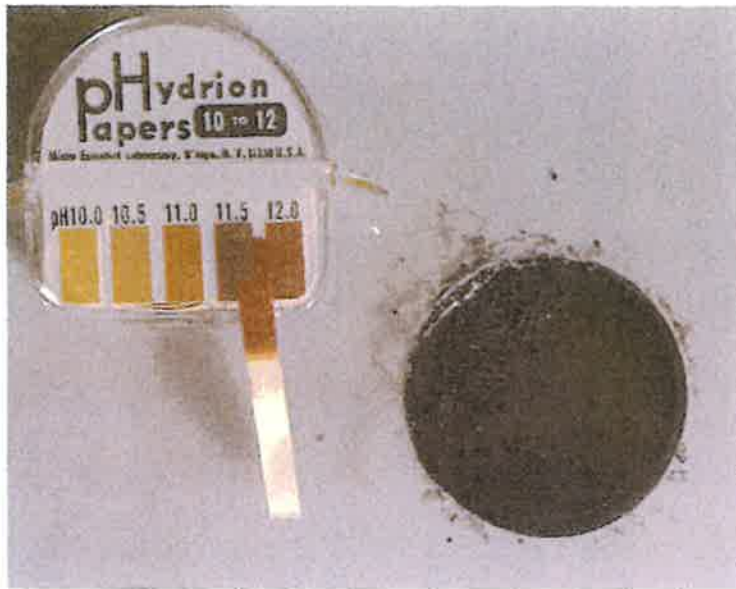
Figure 7. SignaFlor core #3 cavity with highly alkaline water, pH = 11.5 - 12.

In contrast, SignaFlor core #3 was easily removed with no adhesive bond between the moisture mitigation membrane and the concrete. The SignaFlor core remaining completely intact with all its layers present. Figure 6 and Figure 7 show the presence of liquid water in the cavity below the moisture mitigation

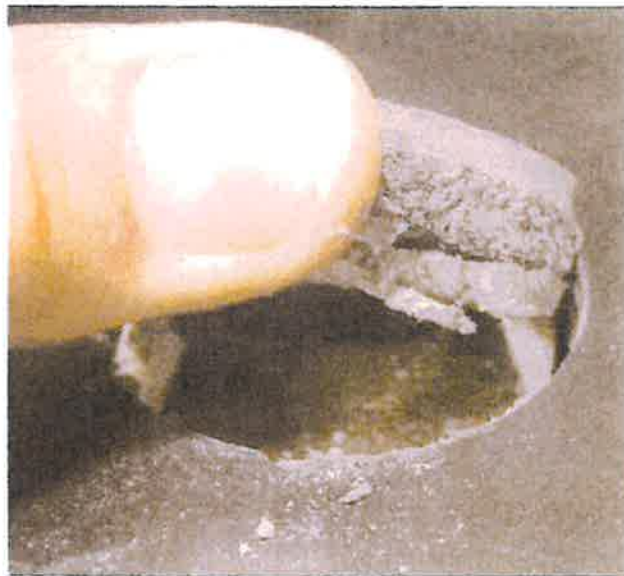
Figure 8. SignaFlor core #4 being removed. Only very weak adhesion to concrete.

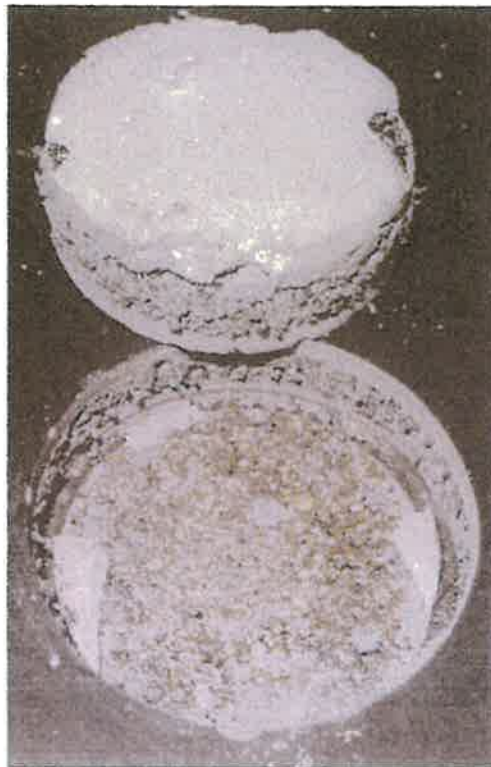
Figure 9. SignaFlor core #4 with moisture mitigation membrane attached to core but not the concrete. Concrete below membrane is damp.

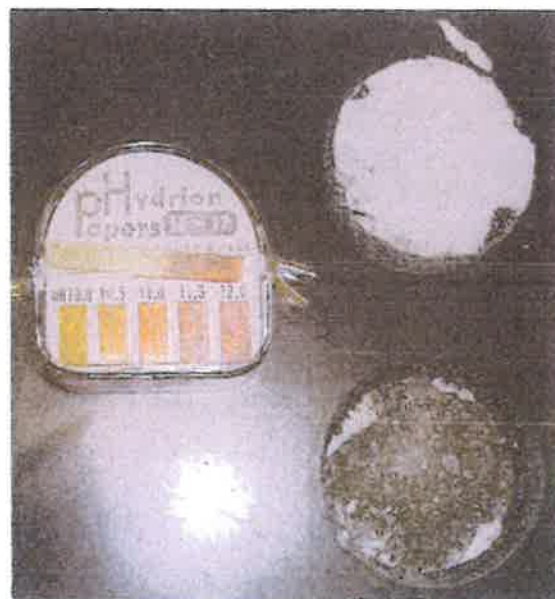
Figure 10. SignaFlor core #4 cavity with highly alkaline water, pH = 11.5 - 12.

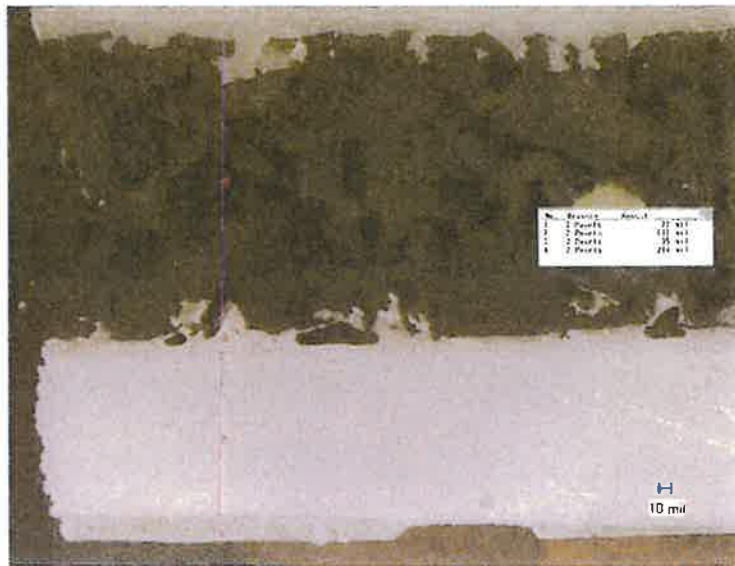
Figure 11. Microscope image at 20X magnification showing a cross-section of the lower portion of SignaFlor core #1. The black layer is the rubber base mat. The moisture mitigation membrane was strongly adherent to the concrete slab. The smooth surface (bottom) is where the SignaFlor system split during forceful removal of the SignaFlor core sample.

Figure 11 and Figure 12 show a digital microscopic image of SignaFlor core #1 in cross-section at 20 magnifications and 200 magnifications respectively. Figure 13 shows SignaFlor core #2 in cross-section at 200 magnifications. Both core #1 and #2 show a smooth even surface at the base of the image where layers of the moisture mitigation system separated during forceful removal, leaving the epoxy moisture mitigation membrane largely attached to the concrete slab. In contrast, the bottom layers seen in the cross-sections of cores #3 and #4 in Figure 14 and Figure 15 respectively are rough, reflecting the contours of the underlying concrete. The roughened surface of the epoxy is consistent with the observation during the on-site core #3 and #4 removal that the epoxy membrane had debonded from the concrete. The concrete surface profile was created during the shotblasting of the concrete floor by CCS to prepare the surface to receive the epoxy moisture mitigation membrane. The roughened surface is critical for the creation of a strong bond between the concrete and the epoxy.

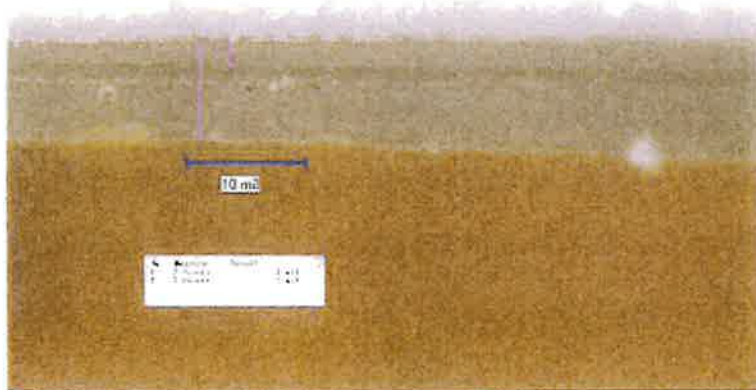
Figure 12. Microscope image at 200X magnification showing SignaFlor core #1 in cross-section. The smooth surface (bottom) is where the SignaFlor system split during forceful removal of the SignaFlor core sample.

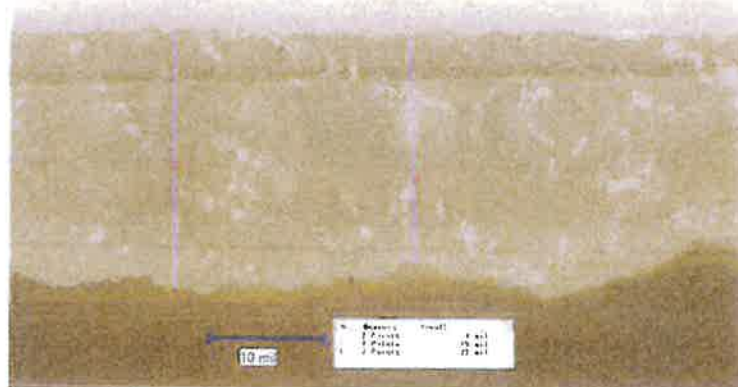
Figure 14. Microscope image at 200X magnification showing SignaFlor core #3 in cross-section with moisture mitigation membrane intact (bottom layer). The membrane had debonded from the concrete and the intact core was easily removed. The uneven surface is the epoxy/concrete interface showing adhesive failure.

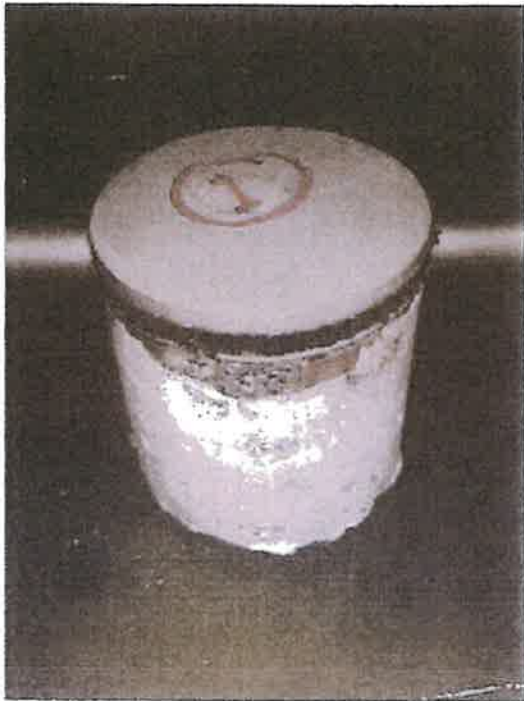
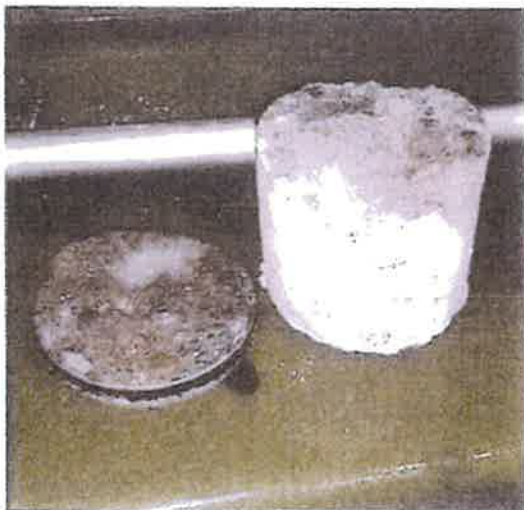
The top layer of the concrete of core 1 separated from the remainder when a chisel was used to break it loose at the base of the core.

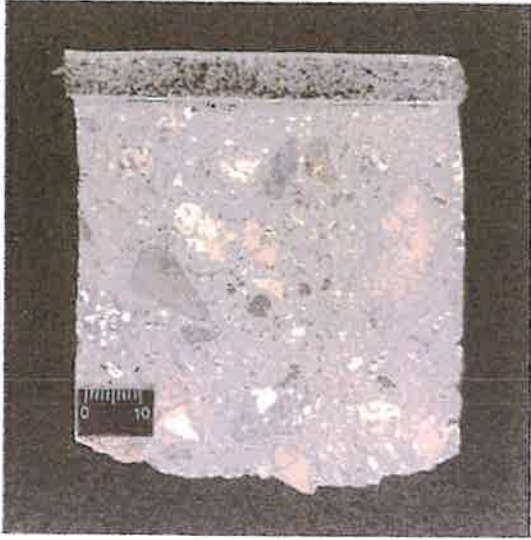
SEI 17576-2.2; MI#20059-02 - Petrographic Data

Slab View		Phenolphthalein

<b>Macroscopic Properties</b>		<b>SEI 17576-2.2 MI#20059-02</b>	
Length (cm) / in	3.2" (8.1 cm)		
Diameter (cm) / in	3.2" (8.1 cm)		
Embedded Objects	Not present		
Cement Color	Light gray (N7)		
Surface Coatings	<p>The flooring construction assembly (base to top) includes the following layers:</p> <ol style="list-style-type: none"> <li>1) vapor membrane (~0.35 mm, minimum thickness 0.19 mm)</li> <li>2) Base resin layer (~1.3 mm)</li> <li>3) Rubber flooring (~7.5 mm)</li> <li>4) Top resin layer [+ urethane (?) top-coat; ~2.5 mm]</li> </ol> <p>Near-surface micro-crack strain with trace accumulations of metasilicate gel are locally present in the uppermost 0.5 mm of the concrete substrate (along ~ 5% of the cross section boundary surface)</p>		
General Condition	Granule & pebble-rich, grain-supported, very poorly sorted, well-graded, moderately porous Portland concrete.

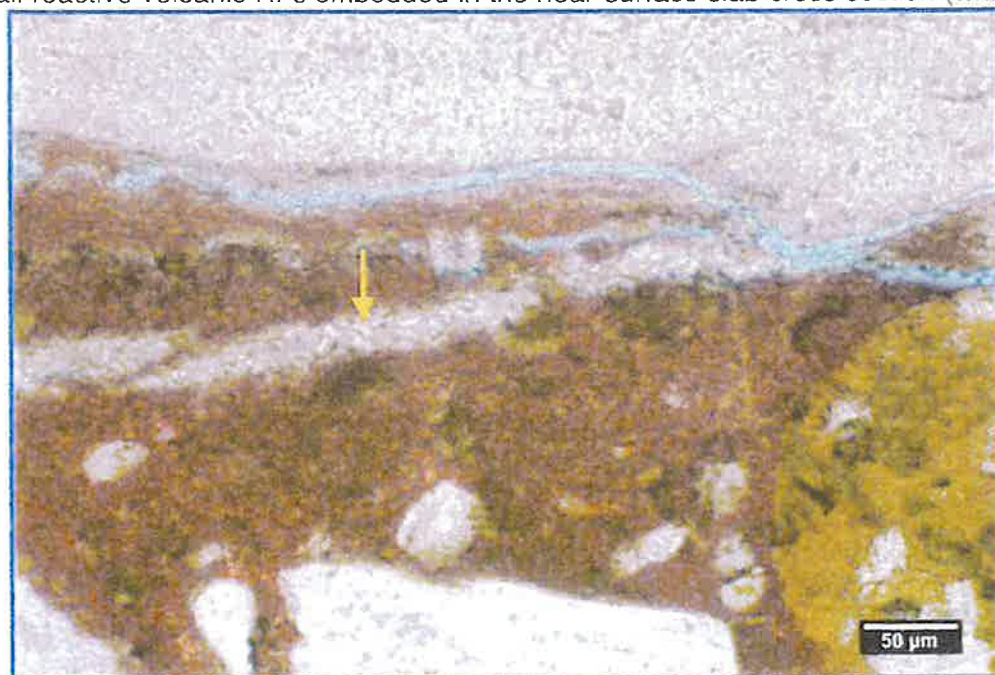
2D. Detail of the crack-filling amorphous metasilicate gel (yellow <).

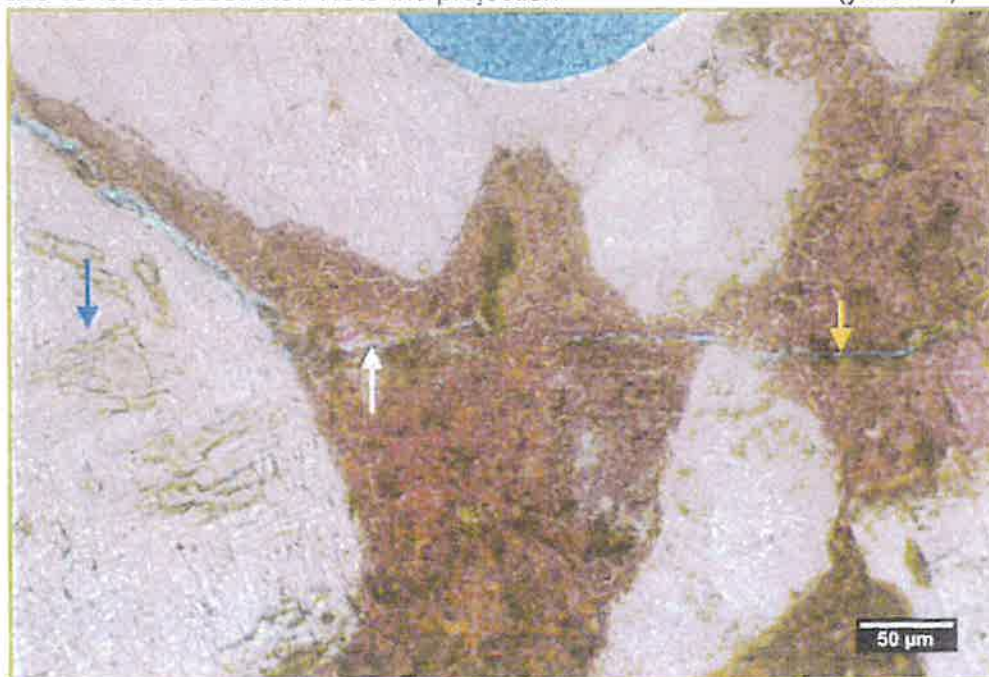
3D. Detailed view of the highlighted area from 3C. The fractures and cracks are locally filled with metasilicate gel (white <) and have weakened the cohesive integrity of the substrate surface.
